The Characterization and Analysis of Ornamental Cast Stone and Stucco from the Palacio Errazuriz, Buenos Aires, Argentina

James Valente Banta
University of Pennsylvania

THE CHARACTERIZATION AND ANALYSIS OF ORNAMENTAL
CAST STONE AND STUCCO FROM THE PALACIO ERRÁZURIZ,
BUENOS AIRES, ARGENTINA

Historic Preservation

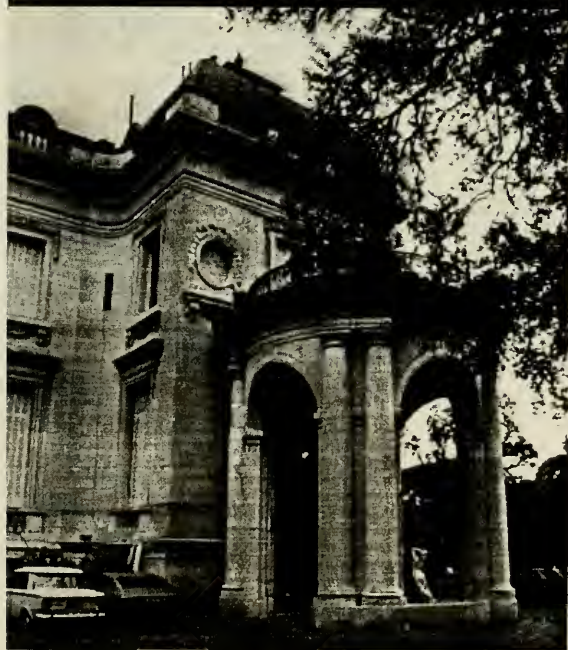
The tholos of the east entrance is over-painted up to the cornice. As this facade is in the worst condition, removal of the over paint will likely expose bad repairs as well as deterioration and damage. Test treatments are recommended for steam, abrasive, and

chemical paint stripping and cleaning of the entrance. The conditions visible now are abrasion and impact loss, delamination and scaling, as well as irregular loss of partial paint layers due to water penetration.

Illustration 7. Palacio Errazuriz,
east entrance and porte-cochere
(view from the northeast).

Illustration 8. Palacio Errazuriz,
east entrance and porte-cochere
(view from the southeast).

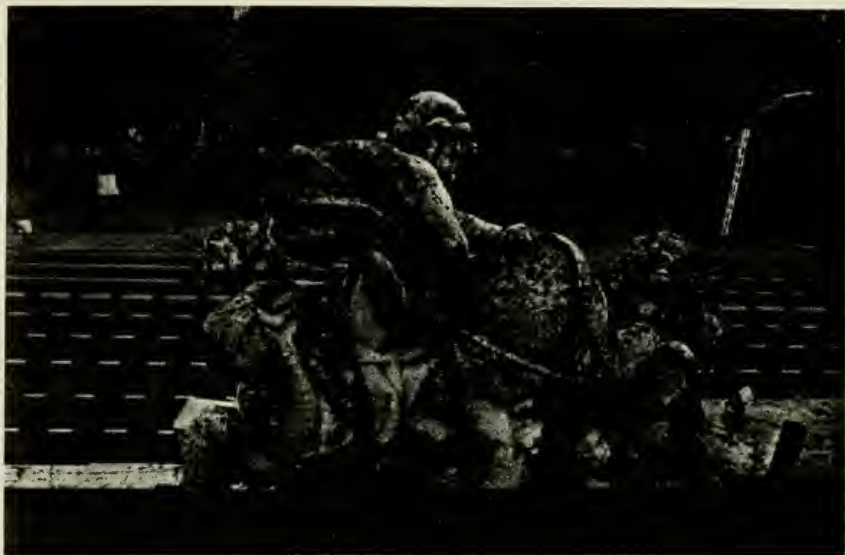
Illustration 10. Palacio Errazuriz, figurative sculpture, north facade.

The natural stone sculpture needs a detailed conservation study. A general water spray at low volume and low pressure could be used to remove overall soiling and black crusts. Localized chemical cleaning using poultices of ammonium carbonate (AB 57) may be required for removing the tenacious black crusts. The stone must be consolidated after cleaning. Tests on the stone using ethyl silicate should be made to determine its appropriateness. Cracks and detachments can be injection-grouted with an epoxy or Jahn M40 grout and fill mixtures made of hydraulic lime and sand matching the color and texture of the stone used to fill small cracks. Where necessary, non-corrosive pins should be used for structural repair. Finally, the sculpture should be treated with a water repellent.

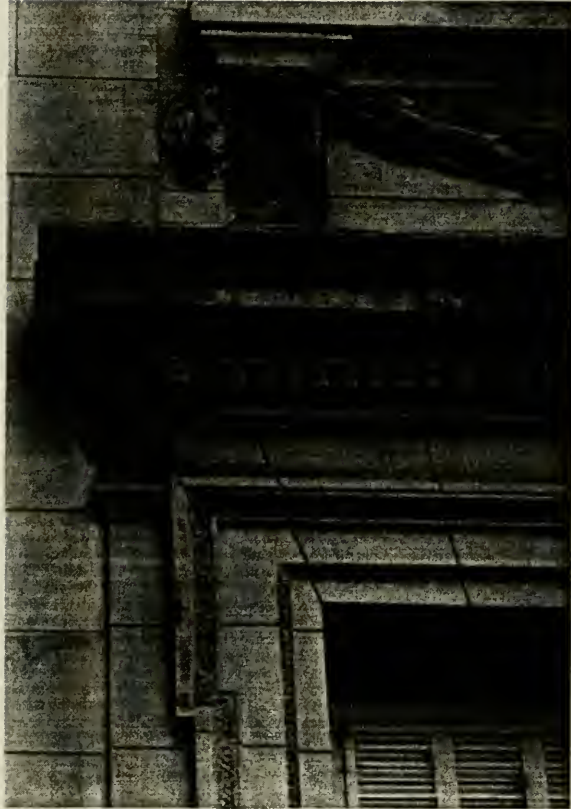
There is evident corrosion of the reinforcing bars that are embedded within the cast stone. (see Illustration 14) Another factor that has led to the deterioration of the cast stone elements may be freeze-thaw cycling.

Illustration 14. Palacio Errazuriz, cast stone loss and exposed reinforcing bars, east facade. Photo by Fabio Grementieri.

For cracks with exposed reinforcing bars, the same preparation outlined above should be carried out. After stabilizing the surrounding cracked cast stone with facings as described above, the exposed reinforcing bar should be mechanically cleaned with an air-

pressurized micro abrasive. All flaking and corroding metal should be mechanically removed, the surfaces degreased, and an epoxy primer, such as Sikadur 22, should then be applied to the remaining metal. For elements requiring additional or replacement reinforcement due to corrosion, new stainless steel and/or threaded nylon rods of appropriate diameter should be installed in combination with an epoxy adhesive such as Sikadur 30. After being treated, all cracks and losses should be filled and finished to match the existing cast stone with a composite mortar repair similar to the original in color, texture, and weatherability.

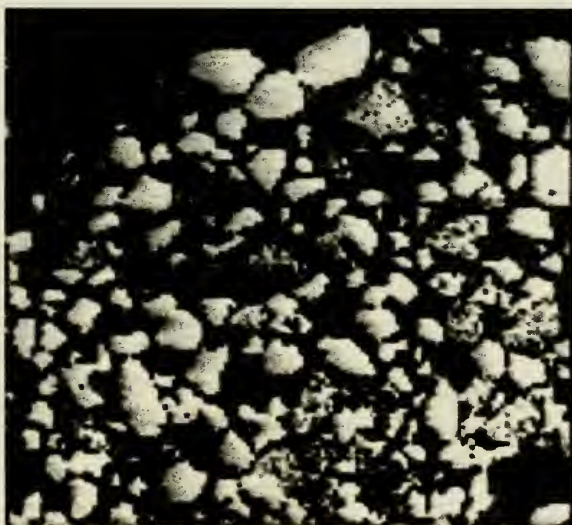
Illustration 18. Sample ER 28, SEM/EDX silicon mapping in cross section. Highlighted areas indicate silicon-rich aggregate.

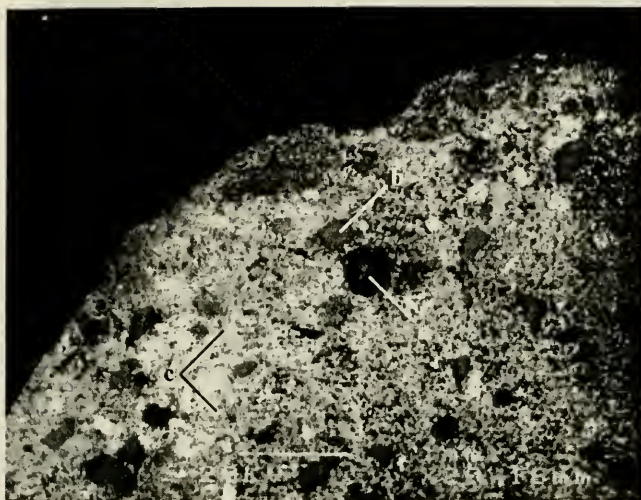
Illustration 20. Sample ER 1, SEM/EDX back scatter electron image in cross section. Note vacuole from casting process (a), aggregate (b), and paste (c).

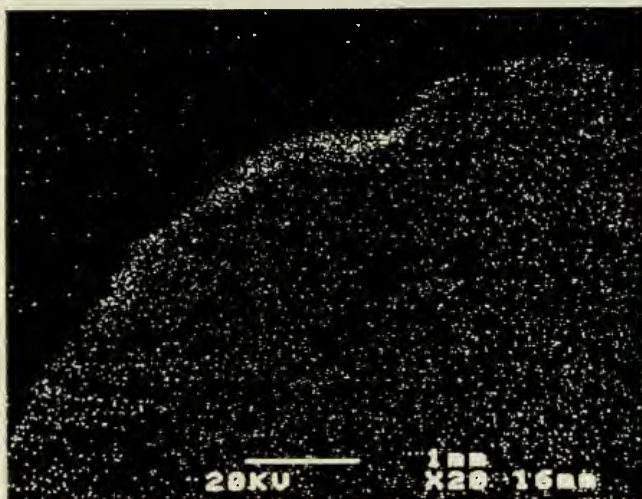
The presence of a sulfur rich crust on samples ER 1 and ER 2 probably indicates the effects of pollution. (see Illustrations 20, 21, 22, and 23) Sulfur in the atmosphere from industrial production combines with moisture in the atmosphere to react with carbonate-rich masonry and forms sulfate crusts. These sulfur-rich surface layers may also be evidence of a gypsum (calcium sulfate) finish or the presence of bacterial action, but the location from which samples ER 1 and ER 2 were taken suggest another theory.

Illustration 21. Sample ER 1, SEM/EDX sulfur mapping in cross section showing sulfur-rich surface.
